Abstract

Case report

Patient: 54 year old. Remaining teeth: 11, 21 and 27 .

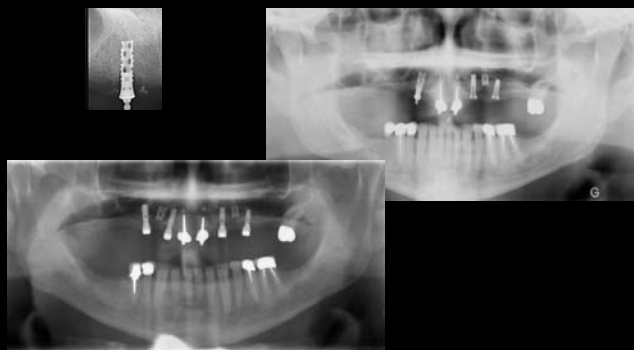
1995

Both implants fractured at the first row of hollows and the osseointegrated embedded portions were left in situ. Subsequently, 2 implants were added mesially and distally to each fractured implant. To retain the RPD, all 4 implants were equipped with magnets (Titanmagnetics, Steco System Technik GmbH, Hamburg, Germany).

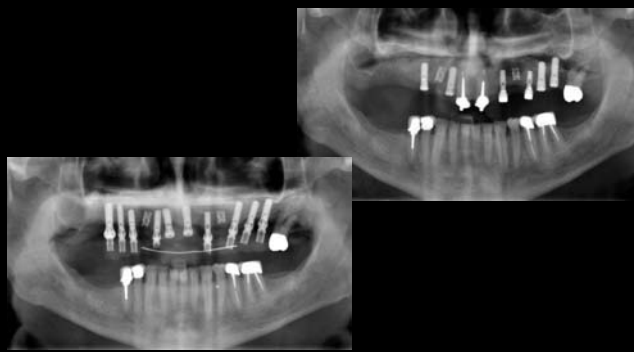
1996 - 2006

All magnets have been replaced 5 times because of wear and fracture ; the RPD was also relined. Due to the high frequency of complications and because of the subsequent failure of the remaining teeth, additional implants were placed after a bone grafting procedure.

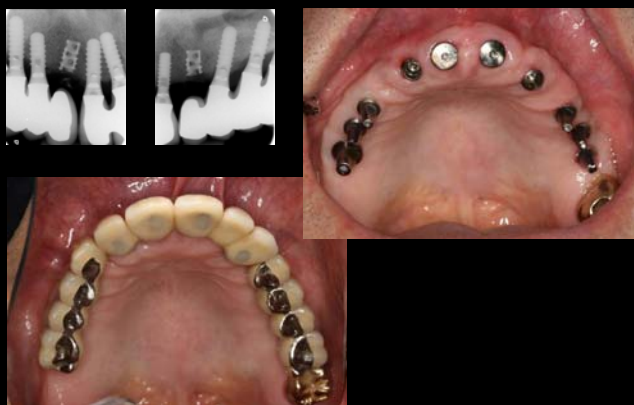
2008 - 2009

Relying on 10 implants, a fixed complete prosthesis was cemented.
